STREAMBANK STABILIZATION IN MICHIGAN - A SURVEY

W. D. Striffler

LAKE STATES FOREST EXPERIMENT STATION

FOREST SERVICE U. S. DEPARTMENT OF AGRICULTURE

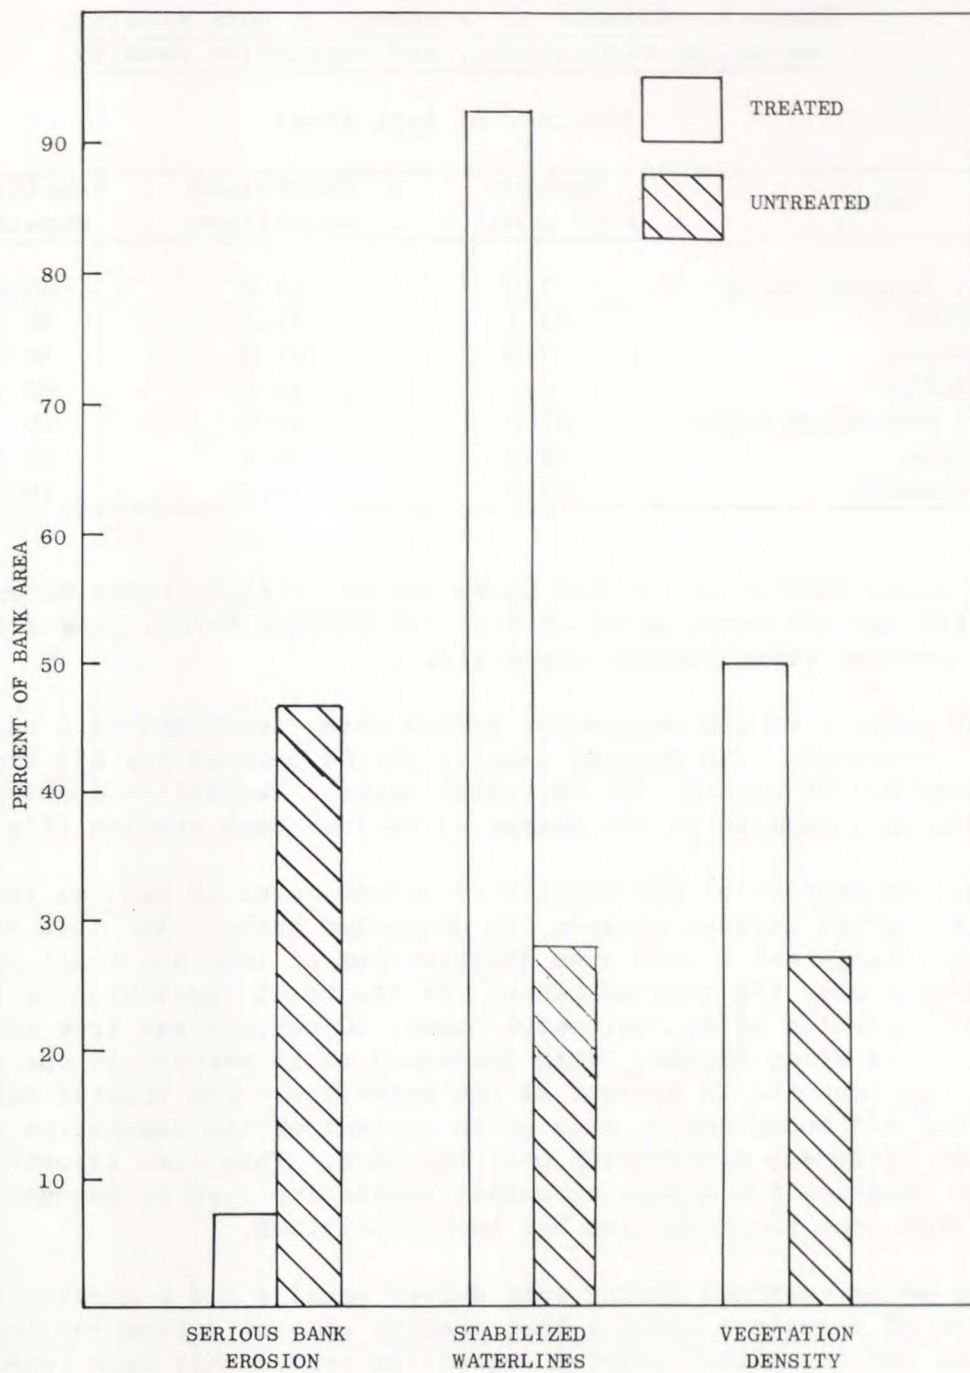
Serious bank erosion occurred on 47 percent of the area of untreated sample banks compared with 7 percent for all treated banks (fig. 3). There was little variation between treated watersheds, with average serious erosion values ranging from 11 to 4 percent (table 3). Untreated banks showed wider variation, with the Pine River having an average of 36 percent and the Tobacco River 59 percent serious bank erosion. This may be due to the differences in land use within the watersheds.

The proportion of stabilized waterline was 28 percent for all untreated banks compared with 93 percent for treated banks. Degrees

Figure 3.--Serious erosion, waterline stabilization, and vegetation density on treated and untreated banks.

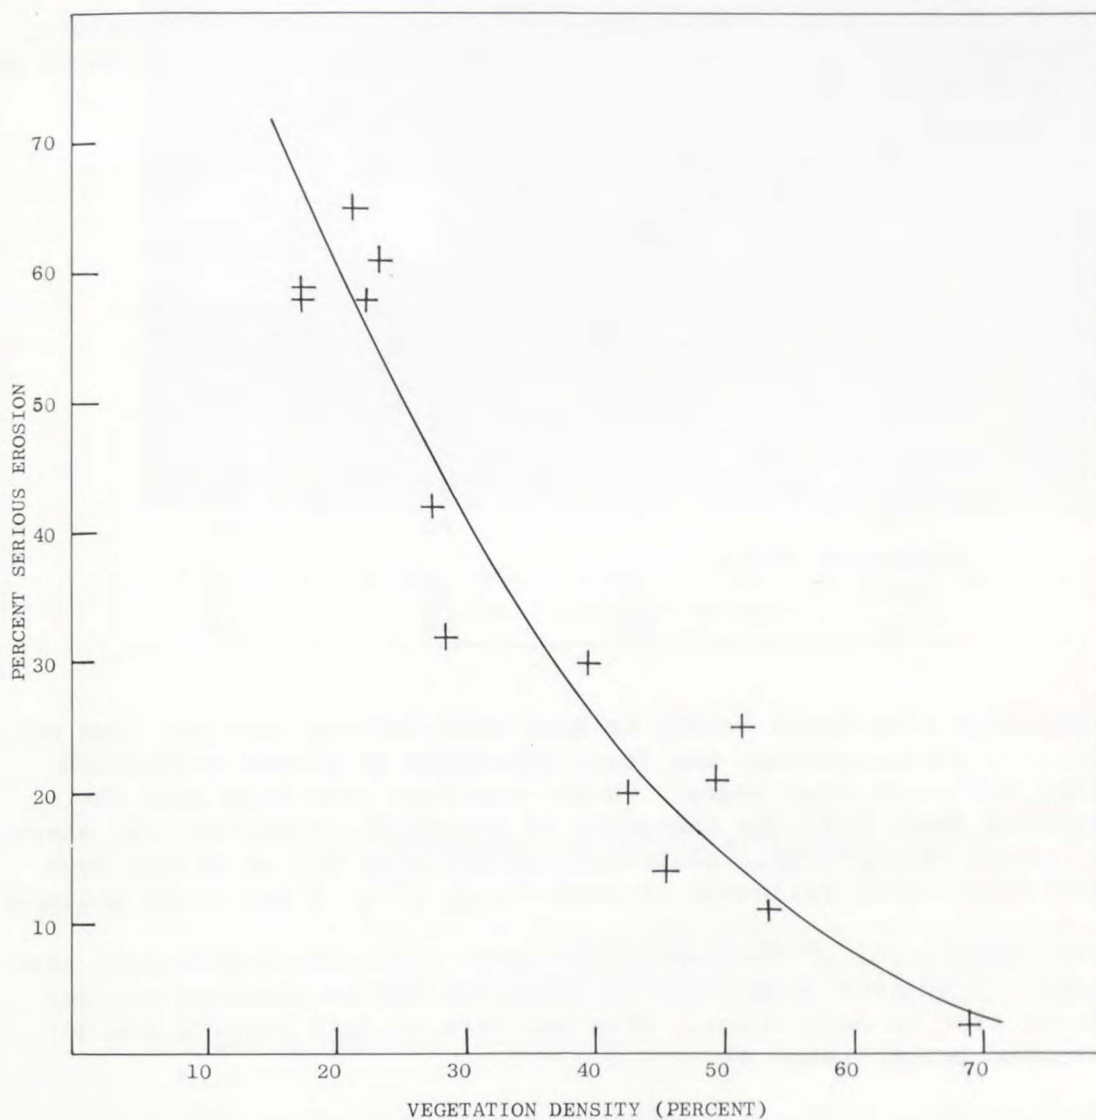
The density of the vegetative ground cover increased as a result of treatment. The average density was 50 percent for all treated banks and 26 percent for untreated banks. Vegetative density was inversely related to the degree of serious bank erosion (fig. 4).

Figure 4.--Relation of vegetation density to serious erosion (free-hand curve).
